Heritage Conservation Management Plan

Port Macquarie Museum

**22 Clarence Street
Lot 1 DP 744652
Port Macquarie NSW**

**SECOND EDITION
Incorporating an
Archaeological Management Plan**

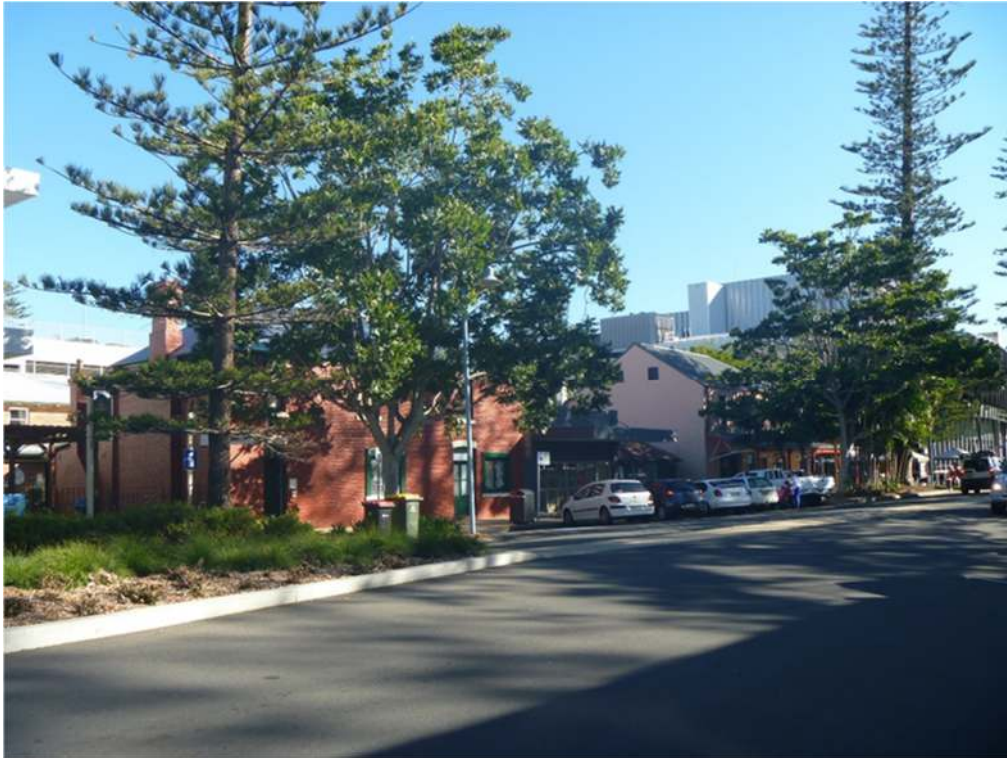
FIGURE 4 – PORT MACQUARIE MUSEUM AND CLARENCE STREET CONTEXT LOOKING SOUTH WEST
NORFOLK ISLAND PINES FORM PART OF THE HISTORICAL STREETSCAPE. COUNCIL PLANTINGS OF ORNAMENTAL TREES IN THIS PRECINCT COULD BE CONSIDERED A DETRIMENTAL ELEMENT TO THE HISTORICAL CONTEXT.

In overview, the historical precinct of the museum complex sits proudly fronting Clarence Street (shown in **Figure 4**), and consists of a two-storey brick building, with a ground floor verandah annexe along the rear elevation, and an underground cistern (water storage tank) also located at the rear of the heritage building. The Museum site is a complex of inter-connected buildings, the footprint of which extends from north to south within the property boundary (see **Figure 5** and **Figure 6**).

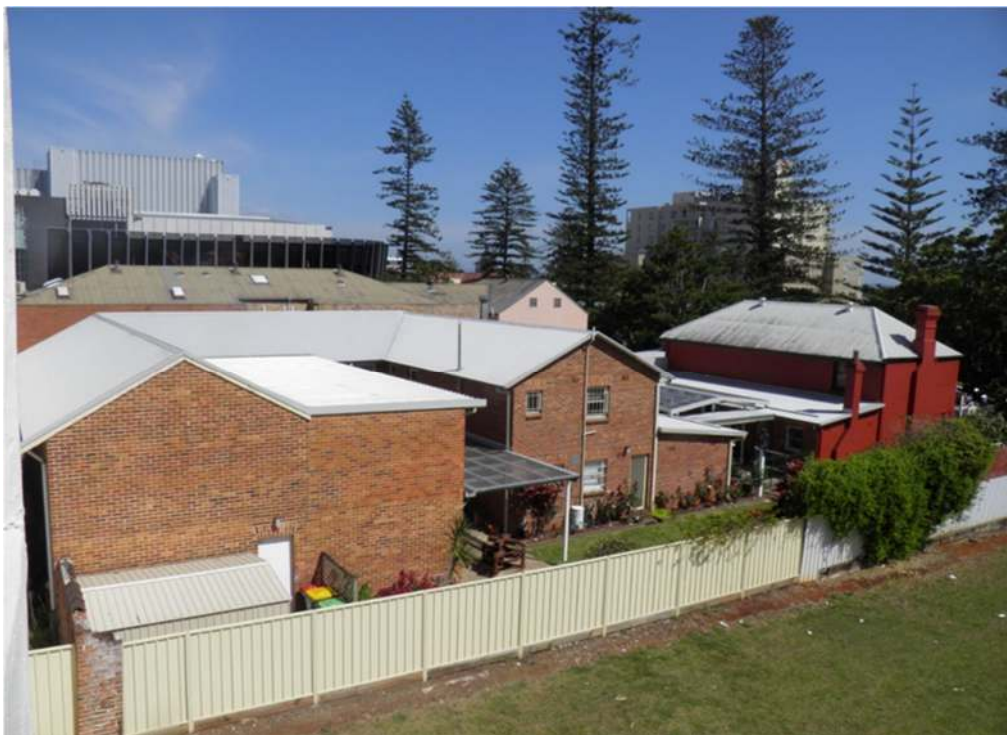
FIGURE 5 – ELEVATED VIEW OF THE PORT MACQUARIE MUSEUM COMPLEX CIRCA 2005
LOOKING NORTH-WEST AND SHOWING MODERN BRICK EXTENSIONS TO THE REAR OF THE HERITAGE BUILDING
AND BRICK INFILL OF THE FORMER TIMBER VERANDAH ANNEXE.

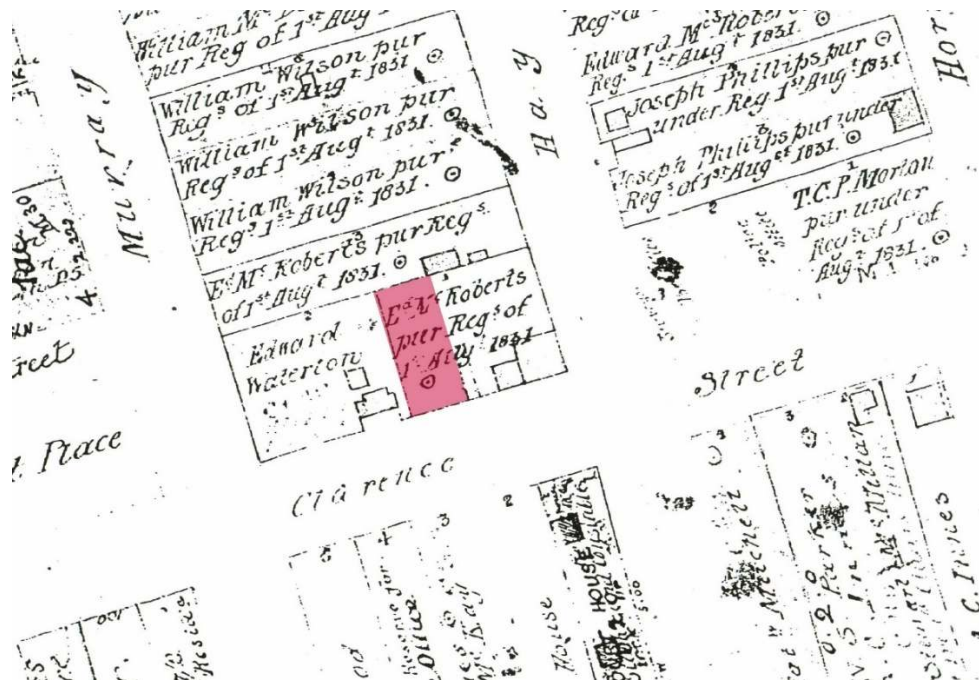
FIGURE 12 – PLAN OF PORT MACQUARIE 1836 HIGHLIGHTING MUSEUM SITE IN RED

The plan of 1836 shows the footprint of buildings in the north western corner of Lot 1 with a long narrow structure to the east and further again to the east, a symbol that appears to indicate a well to the south of the buildings (refer **Figure 12**) but this is more than likely a survey mark.

It appears from this plan that McRoberts did not construct any buildings on the present site of the museum (shown highlighted in red in **Figure 12**).

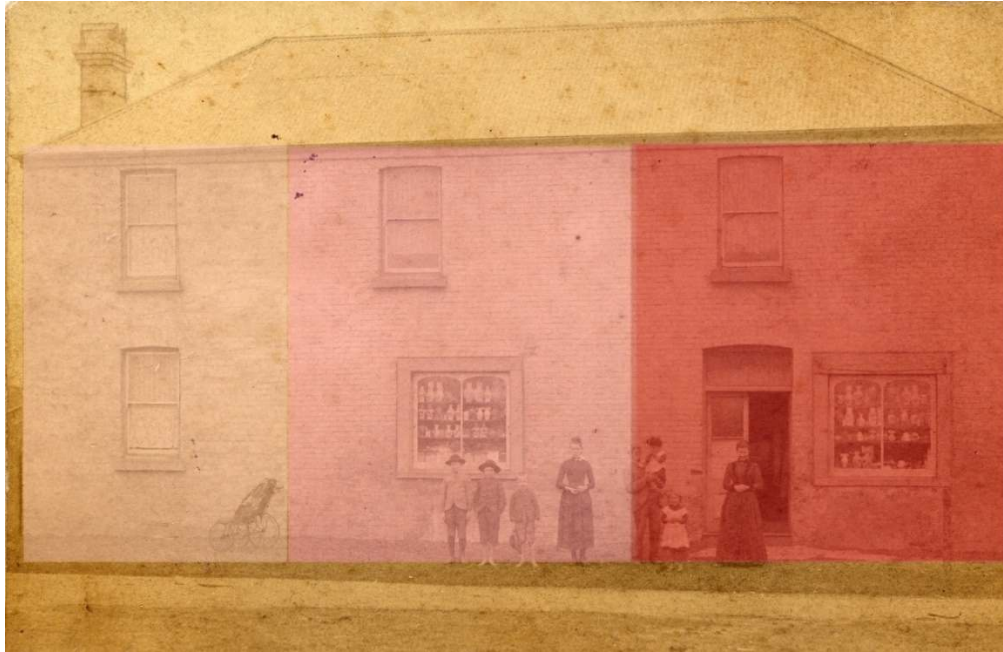
The store was sold in 1925 by Donald Marchment to Albert Percy Hayward who appears to have converted the building into a residence and boarding house. It appears that it was during this time that the eastern ground floor window was converted to a doorway (compare **Figure 16** and **Figure 17**).

FIGURE 16 – POSSIBLE CONSTRUCTION PHASES OVERLAYED ON CIRCA 1895 PHOTOGRAPH. IN THIS VIEW THE MARCHMENT FAMILY IS POSING IN FRONT OF THEIR STORE. FIRST CONSTRUCTION PHASE SHOWN AT RIGHT, SECOND PHASE IN CENTRE AND FINAL PHASE AT LEFT. NOTE THE EASTERNMOST WINDOW (AT LEFT) ON THE GROUND FLOOR WHICH WAS CONVERTED TO A DOORWAY IN THE EARLY 20TH CENTURY.

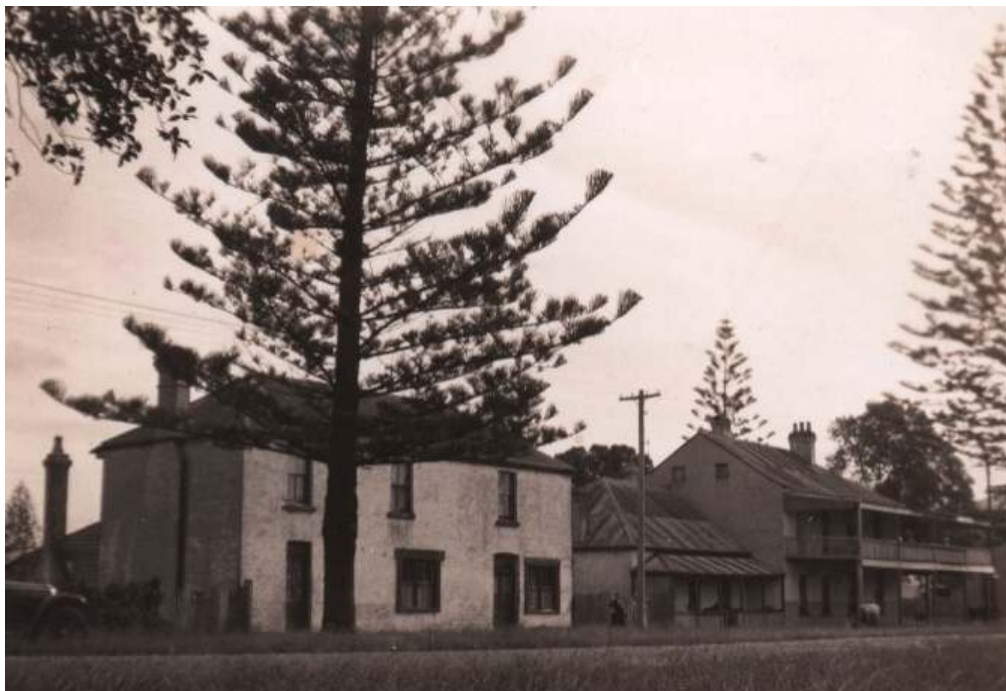
FIGURE 17 – VIEW OF MUSEUM WITHIN ITS HISTORICAL STREETSCAPE CIRCA 1950 OR SLIGHTLY EARLIER. NOTE THE SIZE AND LOCATION OF THE NORFOLK ISLAND PINE STREET TREES.

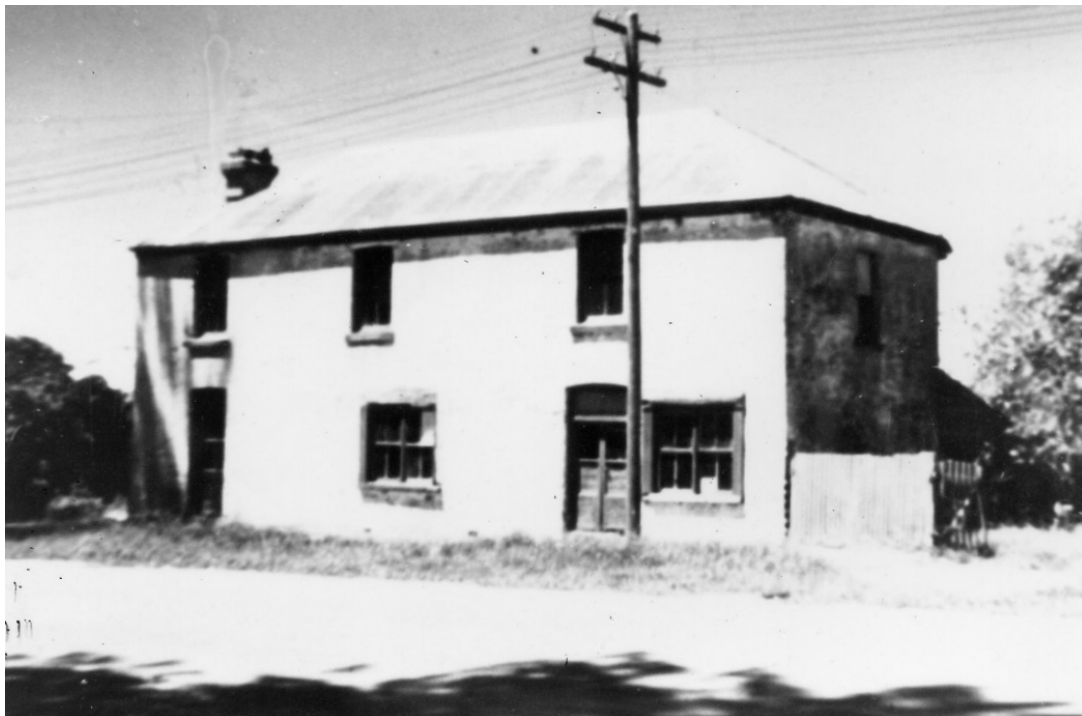
FIGURE 18 – THE FORMER STORE THEN BOARDING HOUSE NOW DERELICT ABOUT 1950.

The building was derelict when first leased by the Society (see **Figure 18**). Restoration work for the 1960 opening included new flooring to the ground floor, a new staircase (since replaced), paintwork, installation of new guttering and erection of the rear annexe (see **Figure 19**). Work was conducted by voluntary labour, mostly Society members, as well as local Service Clubs. A number of extensions to accommodate the needs of the Society and Museum have been made over the years since.

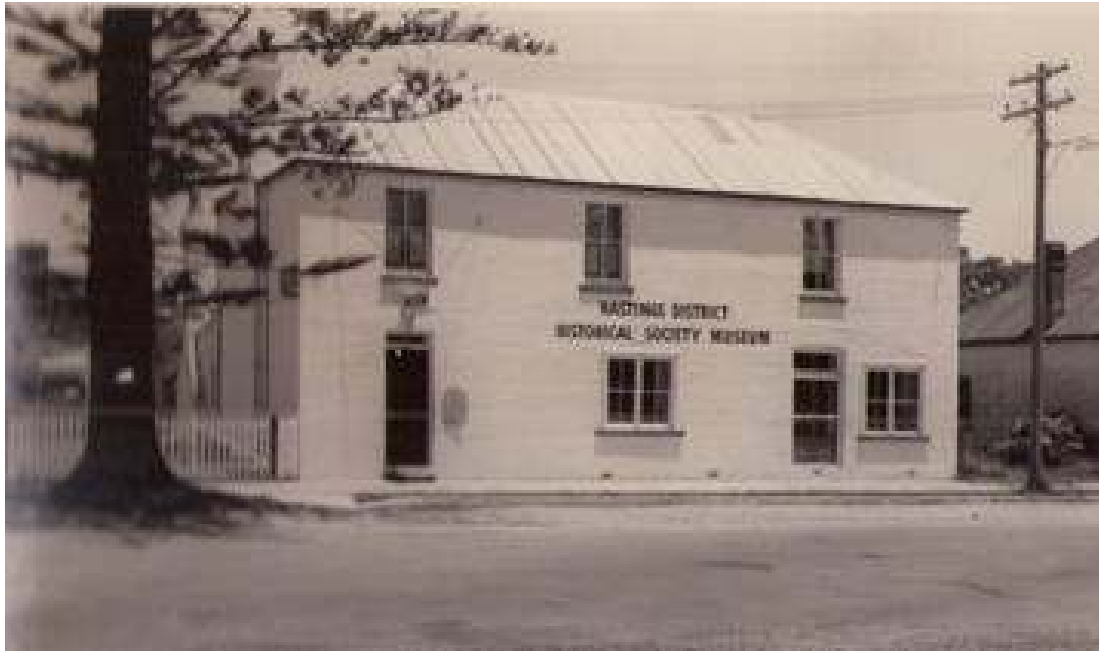
FIGURE 19 – HASTINGS DISTRICT HISTORICAL SOCIETY MUSEUM SHORTLY AFTER OPENING CIRCA 1960.

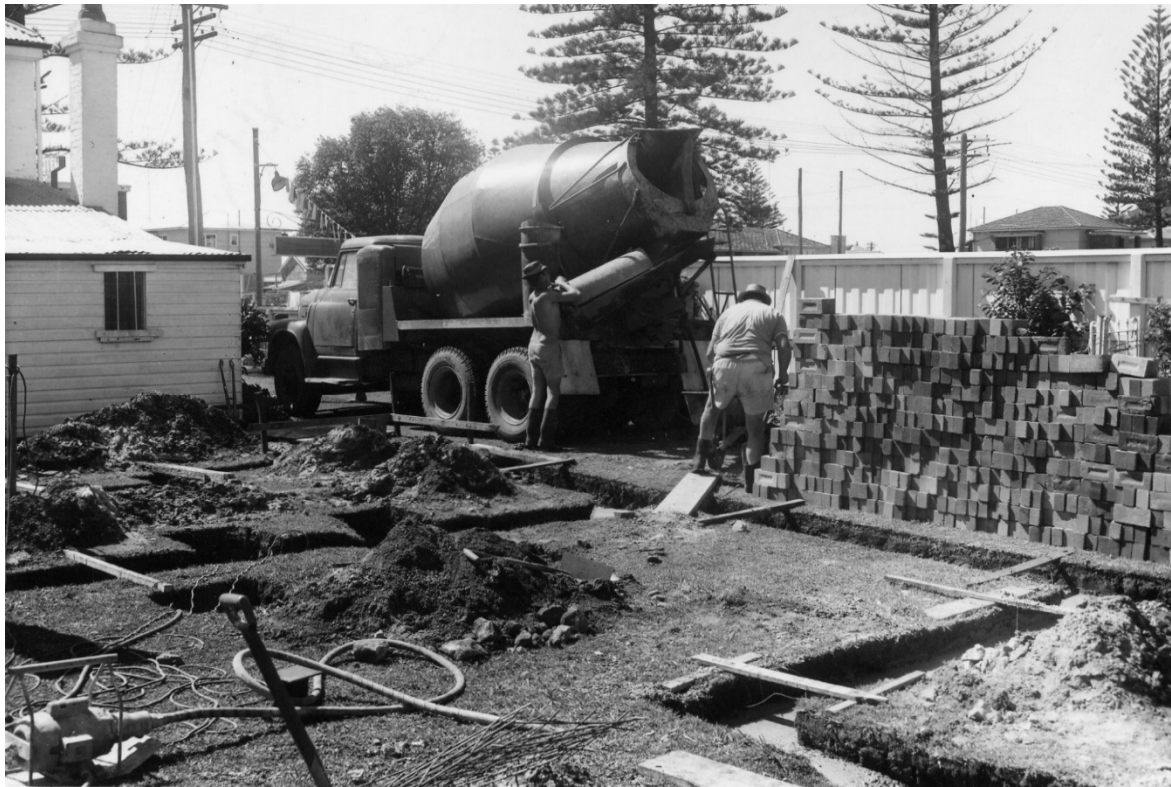
**FIGURE 20 – EVIDENCE OF GROUND DISTURBANCE FOR CONSTRUCTION OF FOOTINGS 1966
SHOWING THE TIMBER ANNEXE AT REAR OF THE BRICK BUILDING AT LEFT OF VIEW.**

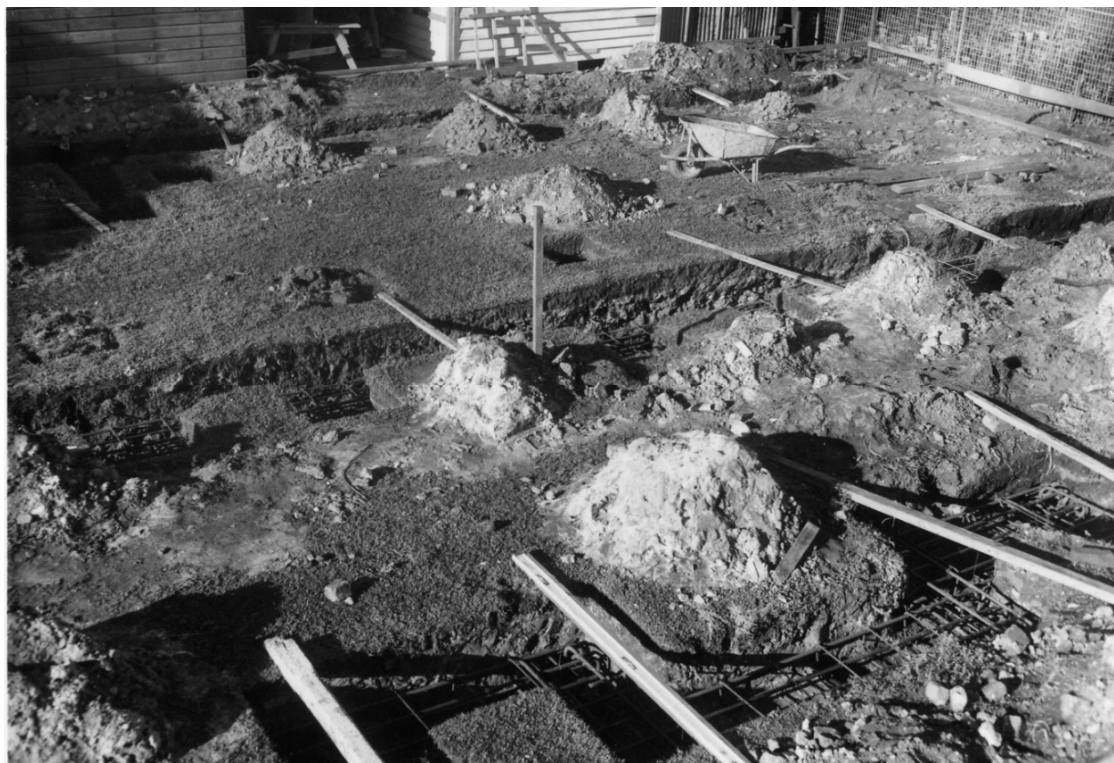
**FIGURE 21 – DETAIL OF FOOTING CONSTRUCTION CIRCA 1960
DEMONSTRATING THE EXTENT OF GROUND DISTURBANCE FOR FOOTINGS. THIS AREA IS NOW PAVED
COURTYARD AND ENCLOSED DISPLAY AREA.**

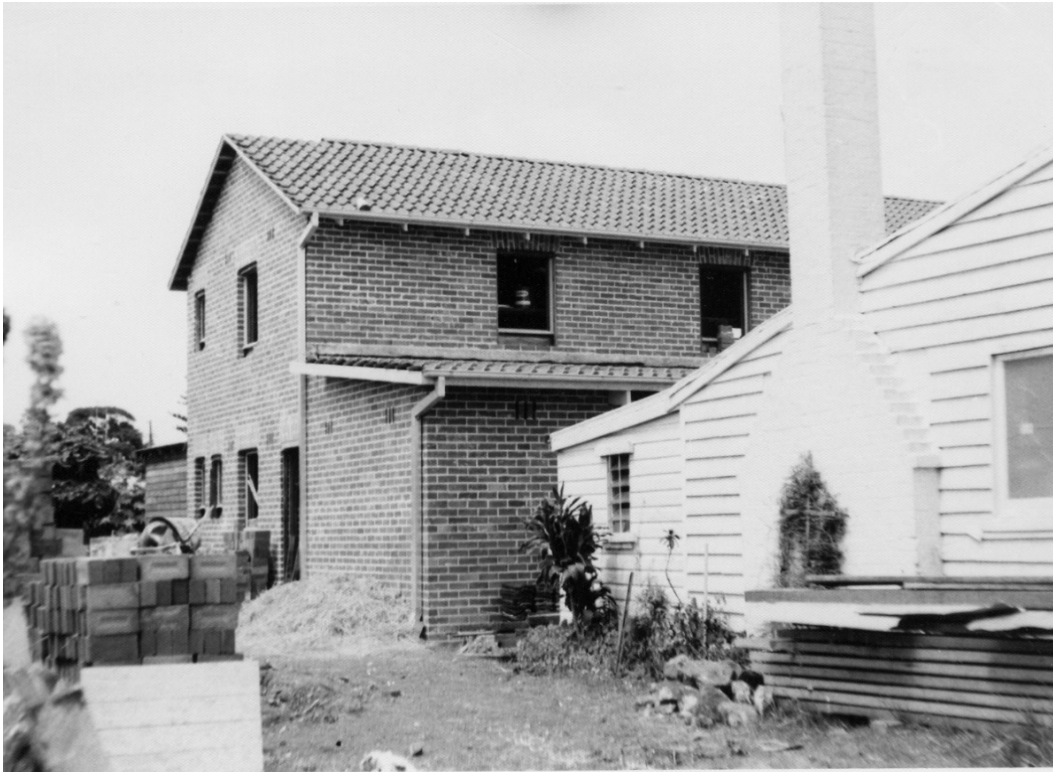
**FIGURE 22 – VIEW OF FIRST STAGE OF MUSEUM ADDITIONS NEARING COMPLETION CIRCA 1960
THIS VIEW IS LOOKING SOUTHERLY -WITH BRICK CHIMNEY OF KITCHEN ANNEXE VISIBLE AT RIGHT. THE SECTION
OF ENCLOSED VERANDAH (CENTRE OF VIEW) HAS NOW BEEN DEMOLISHED. THIS AREA NOW COMPRISES PART OF
THE WALKWAY AND COURTYARD.**

*Major extensions were made on the south side in 1968 (see **Figure 20**, **Figure 21** and **Figure 22**) and in 1977. There were further extensions to the rear of the building in 1988 (Suters Architects Snell, 1991).*

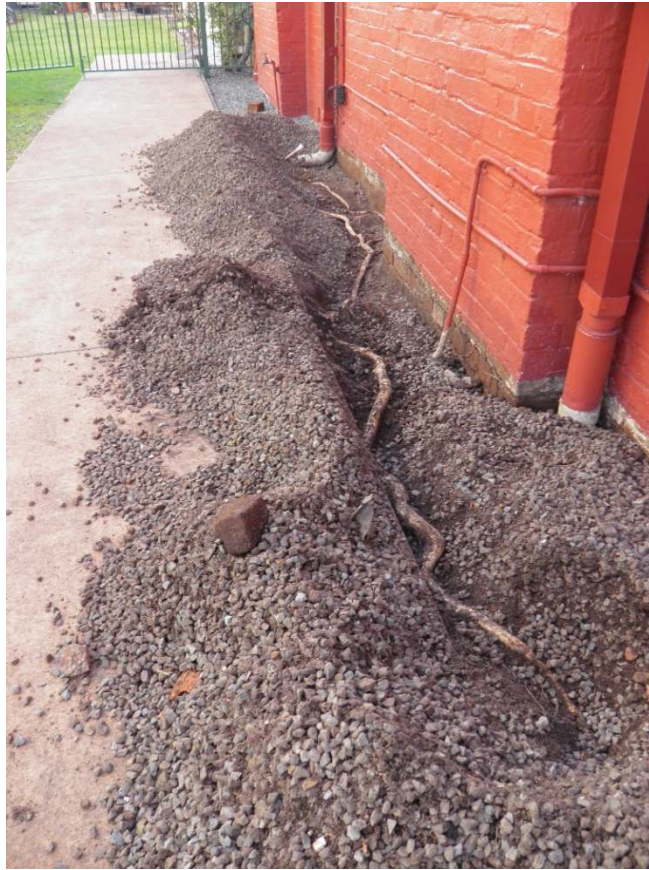
The street frontage of the former store is all but obscured by a Council street tree. While the tree is decorative and provides shade, the root system is invasive and put at risk the integrity of the building foundations (see **Figure 23** and refer **Appendix 4**). The installation of the Forest Courtyard in 2016 presented an opportunity to remove the invasive roots. However, the street tree was not removed and without installation of a root guard, the potential for impact to the heritage building through future root invasion remains.

**FIGURE 23 – INVASION OF TREE ROOTS ALONG BASE OF EASTERN ELEVATION IN 2016
PRIOR TO THE INSTALLATION OF THE FOREST COURTYARD**

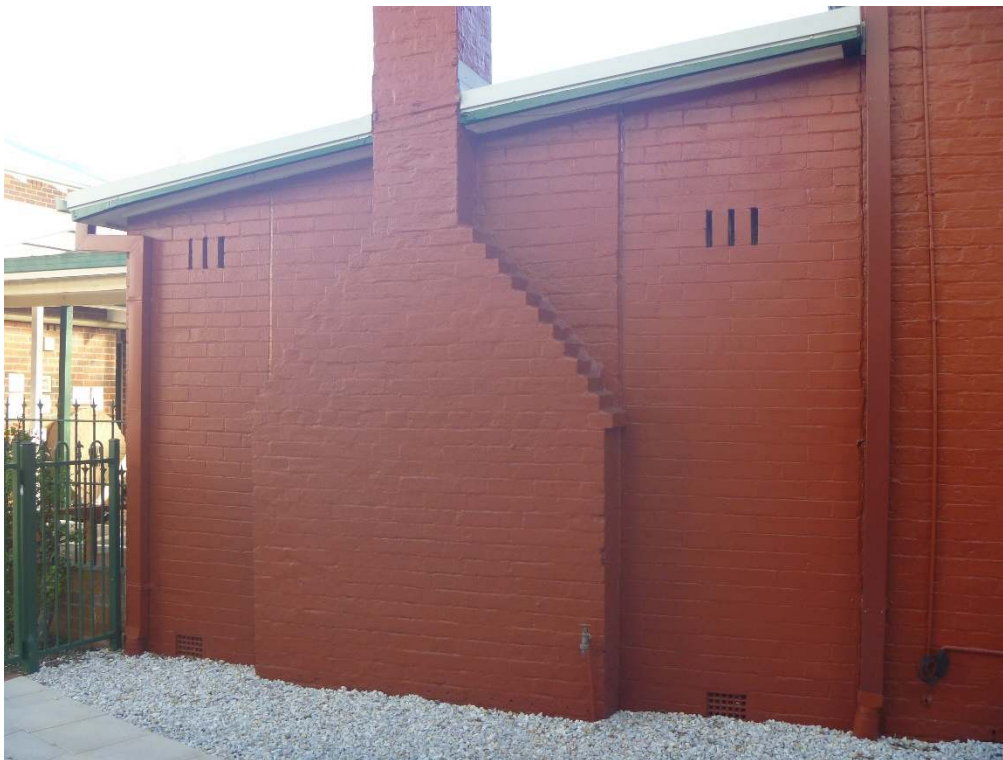
**FIGURE 24 – VIEW OF THE EASTERN ELEVATION OF THE HERITAGE BUILDING IN 2016
FOLLOWING REMEDIATION OF ROOT INVASION AND PRIOR TO INSTALLATION OF FOREST KOALA.**

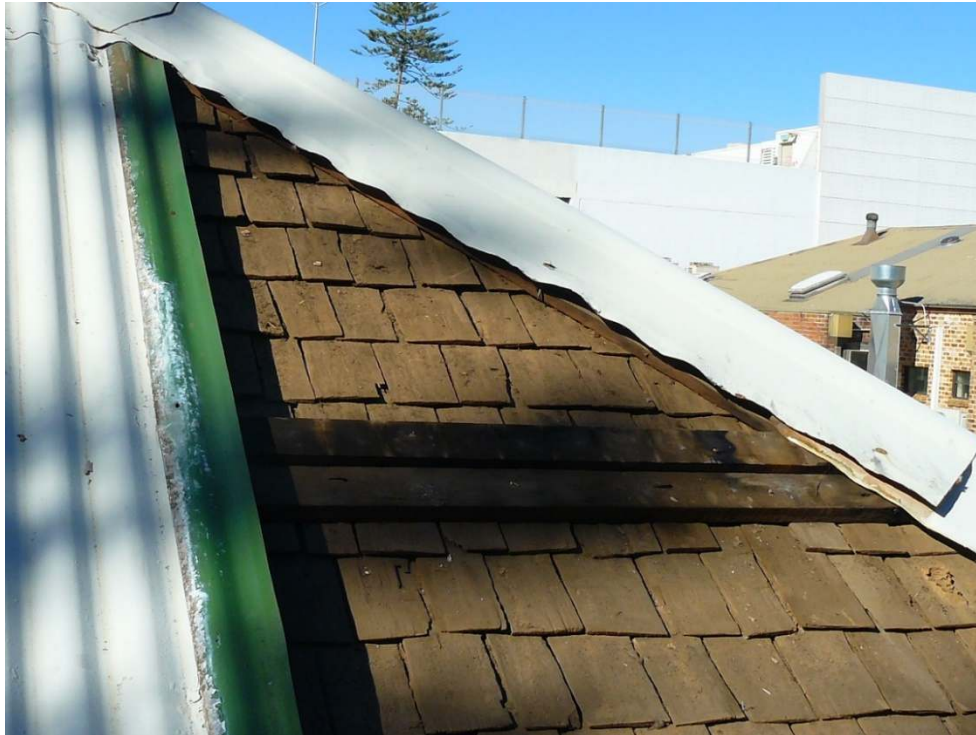
On the eastern elevation, the maroon paintwork disguises the infill brickwork of the kitchen annexe although a distinct difference between the historical and the infill brickwork can be seen on careful observation (see **Figure 24**). With the exception of the late 19th Century eastern extension, timber shingles remain on the roof of the building, obscured from view but protected by a relatively new corrugated iron roof (**Figure 25**).

**FIGURE 25 – SHINGLES OF ORIGINAL ROOF TREATMENT
EXPOSED BENEATH CORRUGATED IRON ROOFING DURING ROOF REPLACEMENT WORKS.**
Source: Port Macquarie Museum

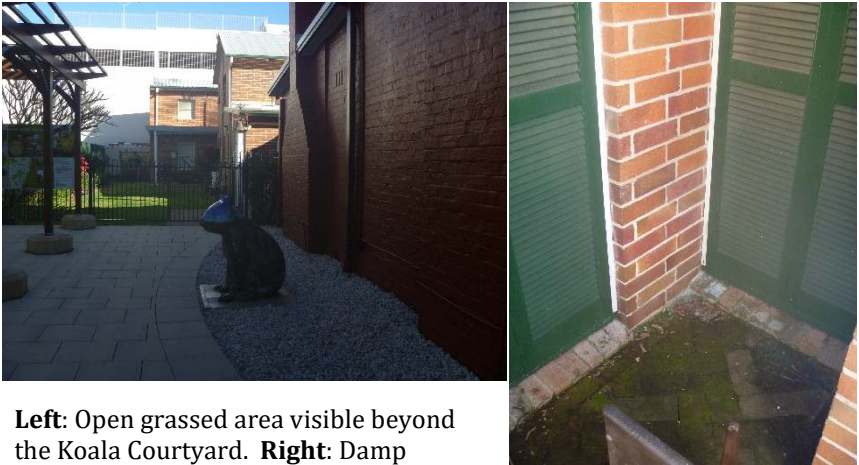
<p>Left: Open grassed area visible beyond the Koala Courtyard. Right: Damp corner where water collects in the covered courtyard.</p>

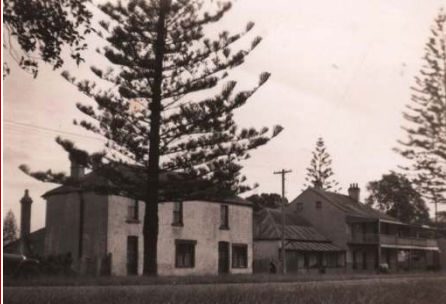
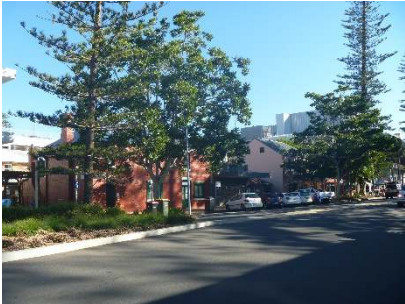
Description	<p>Although now interrupted and surrounded by modern development, the museum is located within a historical streetscape and within close proximity to other heritage listed items (refer Appendix 3 for LEP Heritage Map). Norfolk Island Pines comprise a significant element of the streetscape (refer to cover photograph) and appear in many of the historical photographs in varying stages of growth.</p> <p>Examination of historical photographs indicate that The Norfolk Island Pines were planted around the turn of 20th Century.</p>
Modifications	Redevelopment and infill, loss of road reserve set back.
Condition	NA
Integrity	NA
Significance	The Norfolk Island Pine street trees are assessed as highly significant. Other street trees are assessed as intrusive due to the way in which the street view of the site is obscured, in direct contrast to the historical streetscape.
Recommendations	Remove any intrusive elements such as the council street tree. Consider artistic interpretation of the historical streetscape.

</div> <p>Comparison of street views from approximately the same location: left circa 1950 and right 2017.</p>

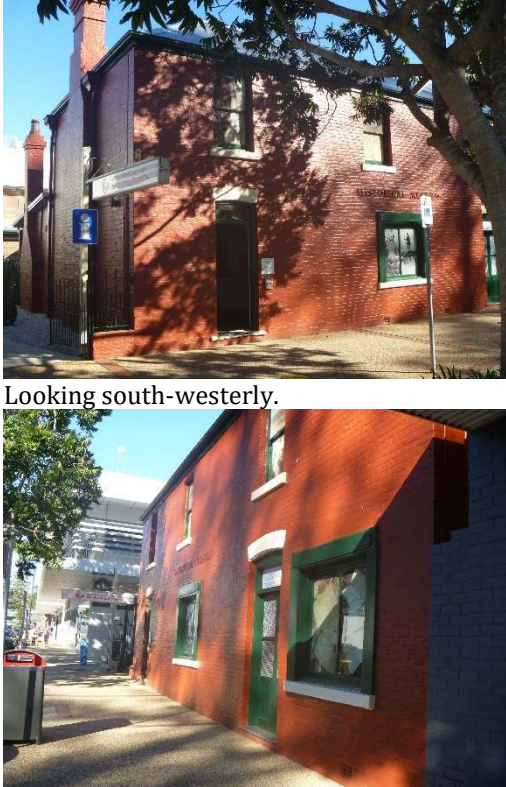
Description	Simply detailed Colonial Georgian style architecture. Painted masonry brickwork laid in English Bond with asymmetrical openings. Concrete pedestrian footpath abuts building footprint.
Modifications	The road reserve has expanded considerably and the concrete pedestrian footpath now abutts the heritage building. Various paint colours on external masonry. The eastern doorway is a modified window opening. Original windows have been replaced.
Condition	Substantially Intact.
Integrity	Minor Modification.
Significance	High but in danger of being consumed by surrounding re-development, the scale of which is not sympathetic to the remnant heritage buildings.
Recommendations	Maintain painted masonry as required. Monitor for rising damp. Monitor for corrosion on metal lintels. Consider interpretation of the building on the street frontage. Avoid any building workw that would result in the reduction of the existing condition and integrity. Maintain a degree of separation from surrounding infill development. Refer to Structural Integrity Report (Appendix 4) for additional specific recommendations.

<p>Looking south-westerly.</p> <p>Looking north-easterly along Clarence Street.</p>

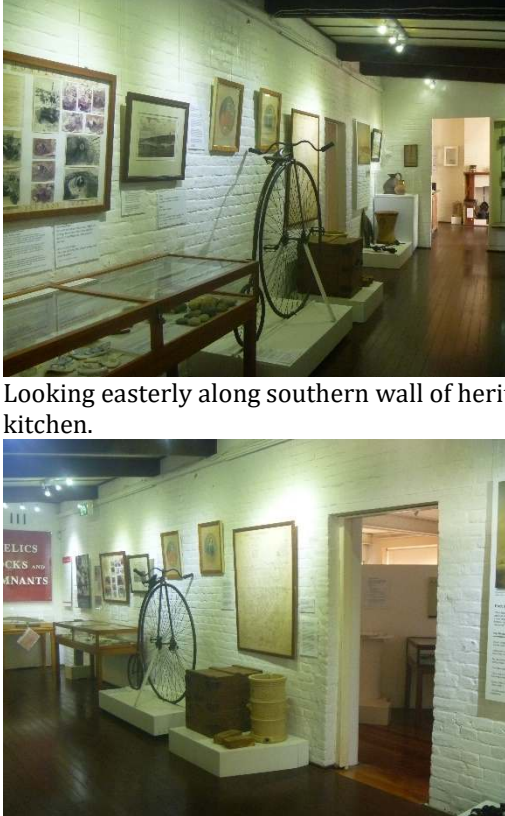
Description	The rear of the heritage building, the former timber annexe, is now enclosed and inter-connected to 1960s museum extensions. It is now exhibition space. The enclosed courtyard and "Well Room" adjoins.
Modifications	Substantial modification to circa 1840 development for which there is little structural evidence remaining. Circa 1880 rear annexe also highly modified but footprint still discernible. New timber floor installed. Open verandah now enclosed for use as museum exhibition space. Loss of open context of rear yard.
Condition	Ruin as the material evidence is incomplete.
Integrity	Major modification.
Significance	Moderate.
Recommendations	Avoid structural modifications to the southern elevation of the heritage building. Monitor masonry for rising damp. Avoid disturbance to the sub-floor context to avoid the destruction of any archaeological resources.
Image

<p>Looking easterly along southern wall of heritage building towards kitchen.</p> <p>Looking westerly along southern wall of heritage building showing doorway created in original wall.</p>

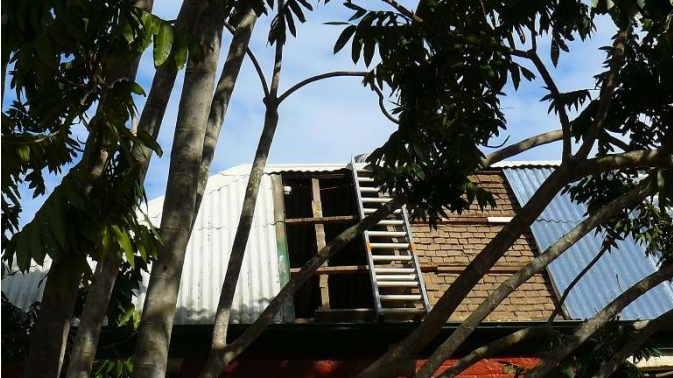
Description	Corrugated iron sheeting, likely first installed in the 1880s at the time of the third phase of construction. Re-roofing in 2016 revealed timber shingles over the first and second phases of development. However, shingle battens were not present in the roofing framework over the eastern extension.
Modifications	Possibly modified from gable to hip. New corrugated iron sheeting installed in 2016. Timber shingles remain in place beneath new sheeting with the exception of the eastern-most extension.
Condition	Substantially intact.
Integrity	Minor Modification.
Significance	High.
Recommendations	Monitor and maintain condition of the timber framework and timber shingles through visual inspection on a regular yearly basis. Any maintenance or structural works carried out on the roof structure should carefully consider the way in which the timber shingles may be impacted. Refer
Image

<p>Exposure of timber shingles during re-roofing showing the absence of shingle battens on the circa 1880 eastern extension. Note the intrusion of the exotic street tree.</p>

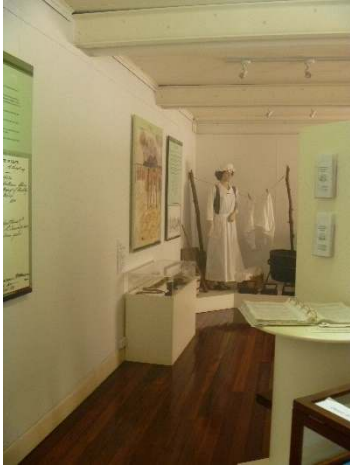
Description	Originally the lower floor of Stokes' residence and converted to a store circa 1840s. Now open area museum exhibition space. Windows covered with an opaque decorative covering and the double door is closed for the purpose of the museum setting and to control light and heat infiltration to reduce potential damage to museum items.
Modifications	Internal fittings of former store lost to modification for boarding house and museum. Steel bracing installed to support first floor bearers. New floor installed with access portal to subfloor. Ventilation installed in sub-floor.
Condition	Substantially intact.
Integrity	Material modification.
Significance	High.
Recommendations	Monitor internal masonry for rising damp and for accumulation of brick dust indicating erosion of masonry from first floor movement. Avoid disturbance to sub-floor deposits which may contain archaeological relics.
Images

<p>Displays in Foundation Room showing steel girders supporting floor (above) and sub-floor access portal.</p>

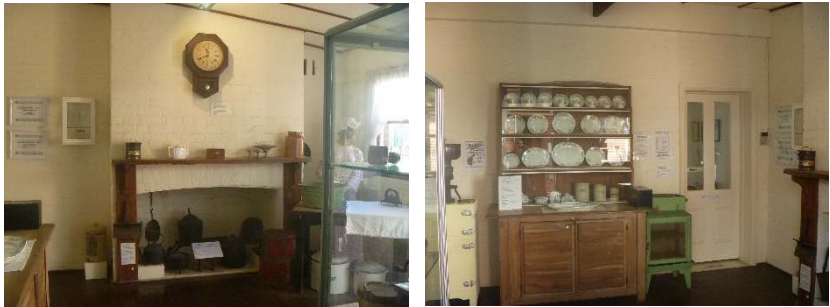
Description	Rear annexe containing brick cooking hearth exhibited as a kitchen within the museum setting.
Modifications	Originally enclosed with timber cladding but modified during the 1970s museum works and alterations when the timber was replaced with brick. Original doorway of southern wall of main building sealed and a new doorway installed.
Condition	Substantially intact.
Integrity	Minor modification.
Significance	High.
Recommendations	Monitor masonry of fireplace for rising damp. Refer to Structural Condition Reports, Appendix 4, for specific recommendations.
Images

<p>Kitchen hearth (left) and southern elevation of heritage building showing re-located internal doorway (right).</p>

Kitchen Fireplace	Constructed at the time of the eastern extension circa 1880s. Masonry over the internal arch is supported by a steel flat bar. A new damp course and new damp course were installed in 2008.	Heavily corroded steel bar causing visible damage to masonry. Brickwork at base exhibits possible signs of rising damp within the masonry. Monitor for signs of instability in masonry.	Seek funding to investigate the need for preservation works or replacement of the steel bar of fireplace. Monitor rising damp and investigate options for improvement of the rear courtyard drainage (see item below).
Paving Rear Courtyard	The brick paved courtyard abuts the rear or southern elevation of the heritage building.	The paving is poorly graded with no formal surface drainage to piped stormwater drainage. Evidence suggests that water may lay in this area for extended periods. This may result in wetting of the sub-floor spaces of the adjacent heritage fabric.	Seek funding to engage a professional tradesperson to assess the drainage issues of the rear courtyard and propose an upgrade to improve drainage and increase ventilation in areas adjacent to the heritage building.

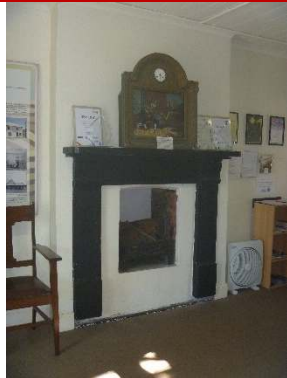
Description	Part of easternmost extension where entry door was originally a window. Point of entry from Clarence Street into museum. Contains fireplace and stairs to upper level.
Modifications	Connecting doorway to Foundation Room. Replacement of stairs. Doorway to kitchen relocated.
Condition	Substantially intact.
Integrity	Minor modification.
Significance	High.
Recommendations	Moving the primary museum entry through the garden to the modern extensions would reduce wear and tear on building fabric of the heritage building.
Image

<p>Fireplace in foyer, part of the circa 1880 extension.</p>

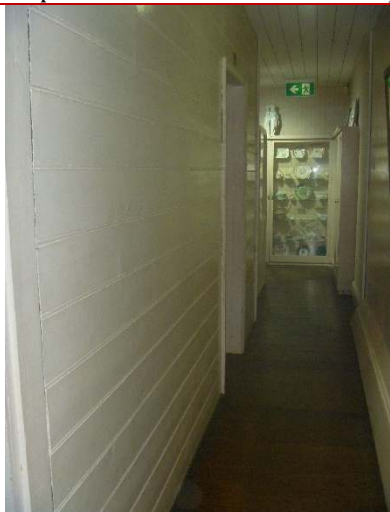
<p>Hallway of first floor, from nursery looking easterly to display of ceramics in dining room, demonstrating timber walls and different skirting.</p>

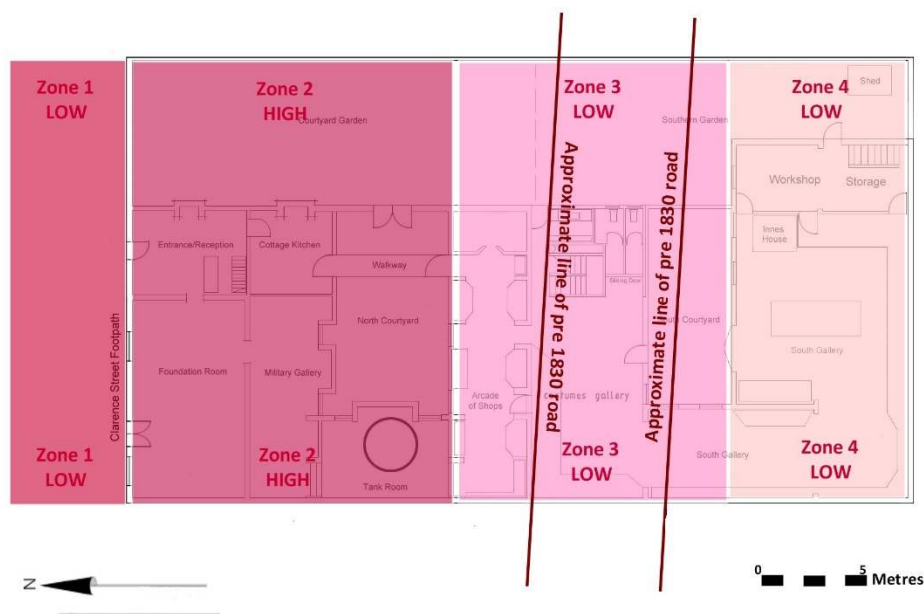
**FIGURE 26 - ZONES OF ARCHAEOLOGICAL POTENTIAL
SHOWING BEST APPROXIMATION OF OVERLAY OF 1830 ROADWAY ALIGNMENT.**

Pre-1830 roadway: Low	The location of the pre 1830 roadway alignment has been overlayed on the zoning plan for context. The portion of roadway transverses the rear of the lot with most of the alignment now consumed beneath museum buildings constructed in the 1960s and 1970s. A portion of former roadway occurs beneath lawn and garden to the east of the building elevations. It is possible that cobbled road formation similar to that excavated on neighbouring sites is still present in the sub-surface on this site.	Redevelopment of this precinct of the site for museum buildings circa 1960s and 1970s has resulted in a high level of disturbance of the sub-surface for construction of footings and trenching for services and drainage. For this reason disturbance of the former roadway alignment has been assessed as moderate to high.	The level of disturbance for building construction has likely resulted in the loss of identifiable sub-surface evidence of the road formation. There is a low likelihood that some evidence, perhaps as isolated cobble formation, remains in the sub-surface of the lawn and garden area. For these reasons the potential for archaeological resources of the former roadway formation to be present across Zone 3 and Zone 4 is assessed as unlikely .	It is unlikely that any relics of the former roadway would contribute new and meaningful information to that already known of the site, other than to confirm the alignment of the roadway which is already confirmed from neighbouring sites. For this reason, anticipated archaeological significance would attain a level of local significance.

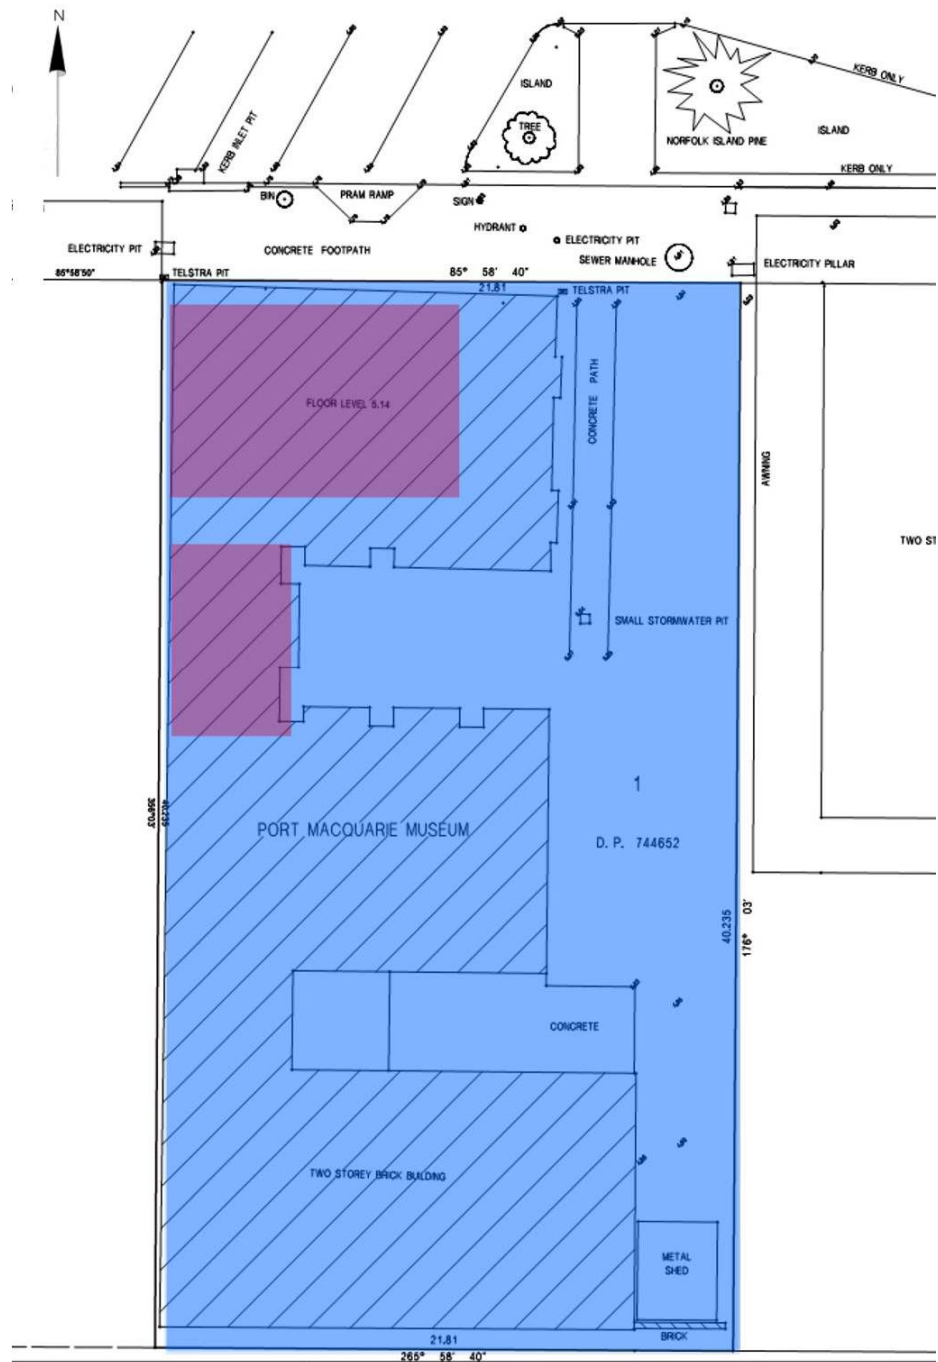
FIGURE 27 – SITE PLAN SHOWING FOOTPRINT OF CIRCA 1830S STRUCTURES OVERLAYED IN RED ON THE FOOTPRINT OF THE PRESENT-DAY MUSEUM COMPLEX
